Manhole Inspection Summary

Manhole # S43C__012MH

Insp Date: **3/17/10 11:05 AM**

Location Address: **Bethel ST.**

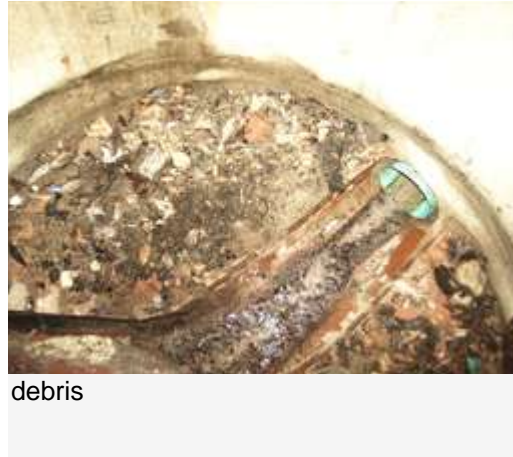
Defect 2

debris

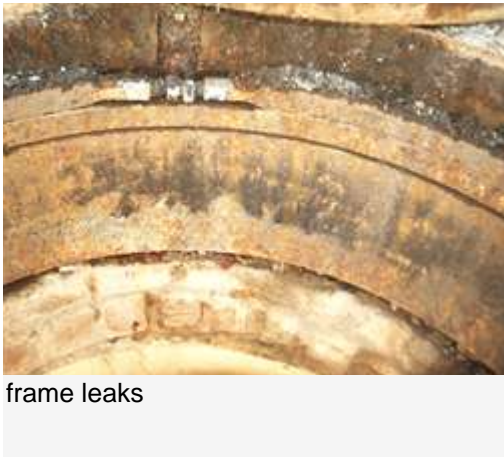
Defect 1

☒ **Leaks**

frame leaks

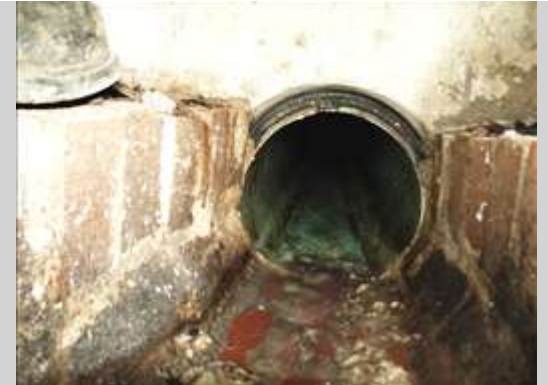
12 O'Clock Outflow

8 in. Circular Gravity Sewer
Pipe Out @ 12 O'Clock

Pipe Height: **12** (in.) Rod and Bar (Angled)
Pipe Material: **PVC** ☐ Pipe Lined
Invert Depth: **12.33** (ft.) Flow Characteristics: **Fast**
Deposits: ☒ None ☐ Mud ☐ Sludge ☐ Debris ☐ Grease
Silt Depth: (in.) Deposits Extent:
Infiltration: **None** Pipe Seal Cond: **Sound**

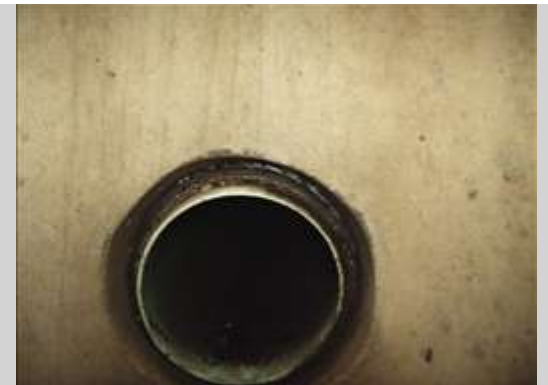
5 O'Clock Inflow

6 in. Circular Gravity Sewer
Pipe In @ 5 O'Clock

Pipe Height: **9.6** (in.) Rod and Bar (Angled)
Pipe Material: **PVC** ☐ Pipe Lined
Invert Depth: **11.75** (ft.) Flow Characteristics: **Slow**
Deposits: ☒ None ☐ Mud ☐ Sludge ☐ Debris ☐ Grease
Silt Depth: (in.) Deposits Extent:
Infiltration: **None** Pipe Seal Cond: **Sound**

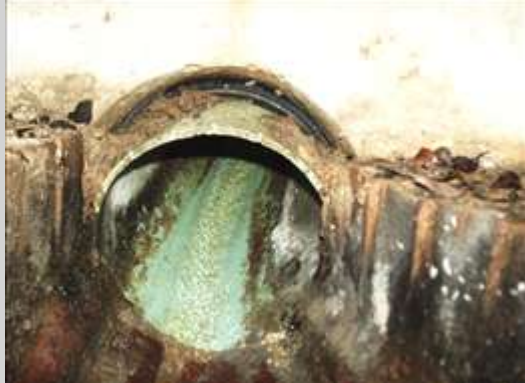
9 O'Clock Inflow

8 in. Circular Gravity Sewer
Pipe In @ 9 O'Clock

Drop: Outside	Rod and Bar
Angled: Yes	Reading: 11.42 (ft.)
	Inv Depth: 12.42 (ft.)
Drop Condition: Open
